‘Welwick’

Measure analysis 34
in the framework of the Interreg IVB project TIDE

December 2012

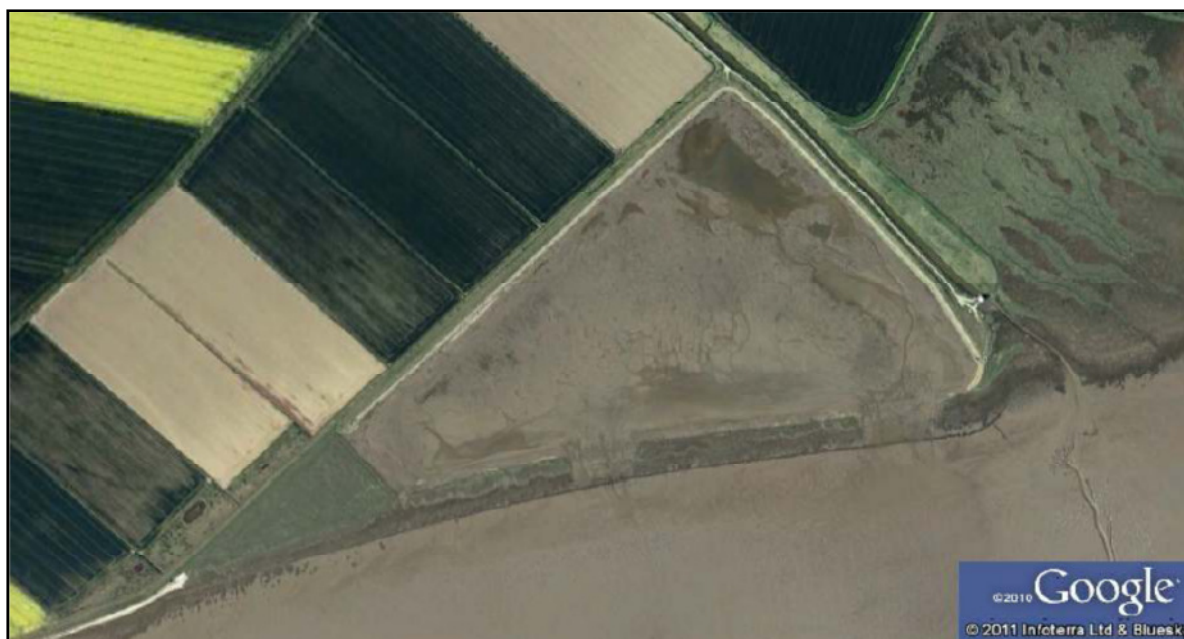
Figure 2: The managed realignment at Welwick - Google Earth derived aerial view

New flood defences were created at the rear of the 54ha Welwick site to a minimum height of 6.1m ODN and were designed to withstand a 1 in 50 year design event. A strip of saltmarsh was expected to develop in front of the new defences. The 70,000m³ of material needed for this defence was obtained from within the site from a combination of reprofiling and creation of temporary borrow pits. The new embankment was seeded and left to stabilise for one year.

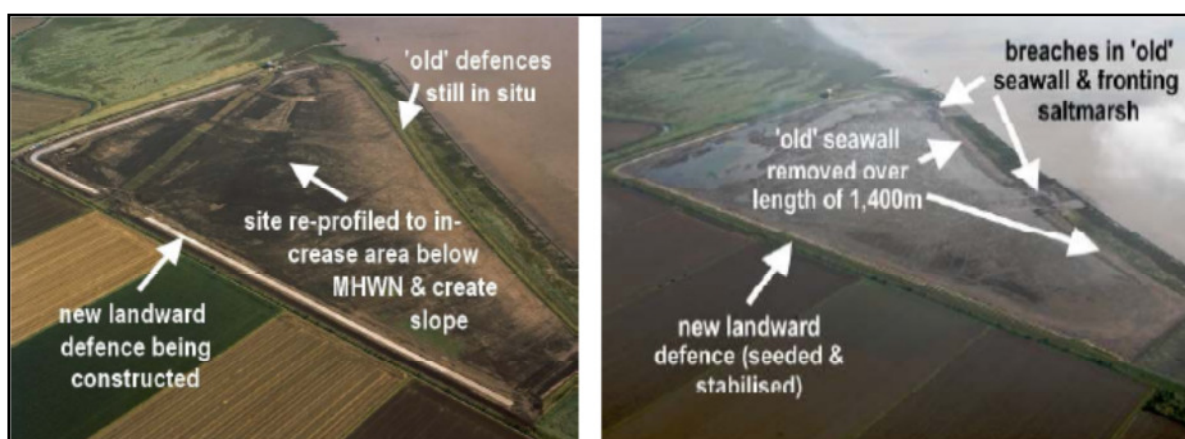
Figure 3: Rear embankment construction and re-profiling at Welwick in 2005 and Figure 3: Welwick shortly after seawall removal (i.e. first inundation) in December 2006

The existing seawall was removed over a length of 1,400m, and the approximately 20,000m³ of the material gained was used to fill the temporary borrow pits. The wholesale removal, rather than the creation of solitary breaches, was chosen for a number of reasons:

- (1) Removal of the rear of the embankment;
- (2) Removal of the rock gabions; and
- (3) Undertaking an overall lowering of the embankment.
