Basic analysis reports

Measure nr^o 20. Walsoorden pilot part A (2004): relocation of dredged sediment to a shallow water area at the edge of the Walsoorden sandbar

Annelies Boerema,
Antwerp Port Authority (APA)

23.01.2013

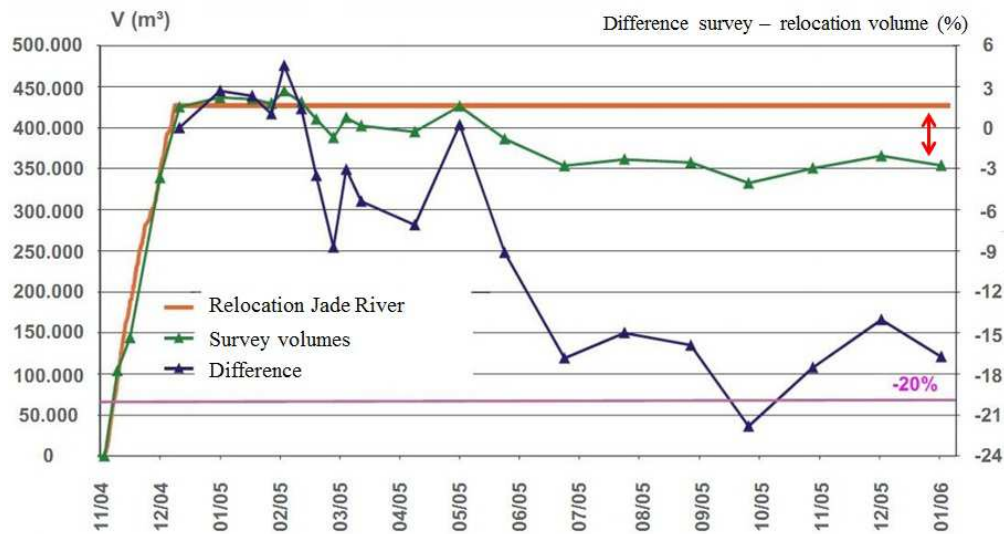
Figure 5. Evolution of the sediment volume for the relocation test 2004. (Plancke and Ides 2007, Ides 2010)

One year after the execution of the in situ relocation test, it was concluded that from morphological viewpoint the test **was a success**. Despite a small loss of sediment directly after execution of the relocation test, which is probably caused by the transport of the finer sands by the currents (i.e. natural segregation), the amount of material within the control area equalled the relocated quantities. Only after 2 months a decrease of volume was measured, a loss of circa 10% after 6 months and circa 17% after one year (Figure 5), which is much lower than the predefined criterium. The main part of the eroded sand is transported during flood towards the Walsoorden sandbar (

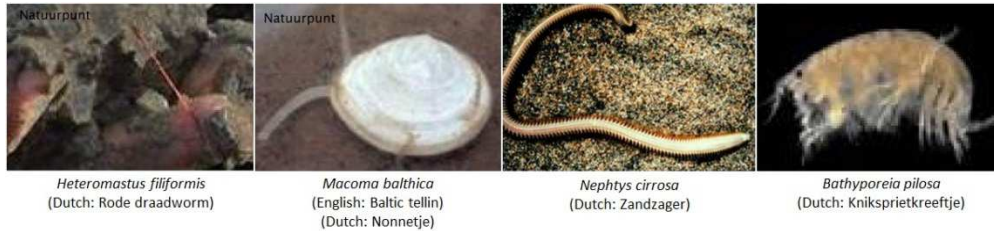
Figure 9. Poor macrobenthos community in the subtidal area around the sandbar (van der Wal 2010)

(2) *Subtidal area.* For the subtidal samples an initial decrease in mud-percentage was found for the impact area. This is explained by the absence of finer mud material in the dredged sediments that were relocated. The subtidal macrobenthos samples did however not show deterioration (biomass, diversity and density) for the impact area compared to the 2 other control areas (Figure 8). Assumably, this can be explained by the fact that the subtidal macrobenthos was already poor before the relocation test (
