'Training Walls at Trent Falls'

Measure analysis 37
in the framework of the Interreg IVB project TIDE

S. Manson ¹, N. Pinnington ²

December 2012

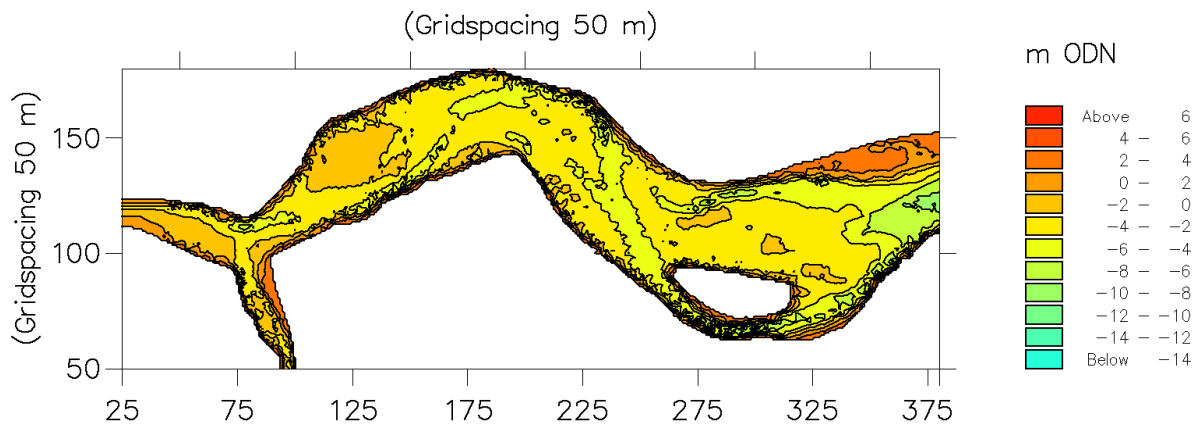
Figure 1: 1925 Bathymetry

The reason for the walls was that the main channels originally moved, due to the relative strengths of flow from each tributary entering into the Humber Estuary, which caused the main channel to move. When the Trent flows were more dominant, the main channel was pushed north wards. When the Ouse flows were more dominant, the channel was pushed into a more central location. The purpose of the Training Walls was to help stabilise the banks and channels in the entrance to the Trent and Ouse in order to aid navigation, as the channels were continually changing and becoming hazardous to navigation. The walls created an apex to the Trent flowed into the lower estuary to match the Ouse flow to stabilise the channel and ensure more consistent and stabilised bed levels, which made this section of the estuary easier to navigate. The works effectively created a flow in and out of the Trent, which merges with the Ouse flow at small (acute) angle, before the intersection was more obtuse and, depending on relative flow conditions from each river, the banks moved.

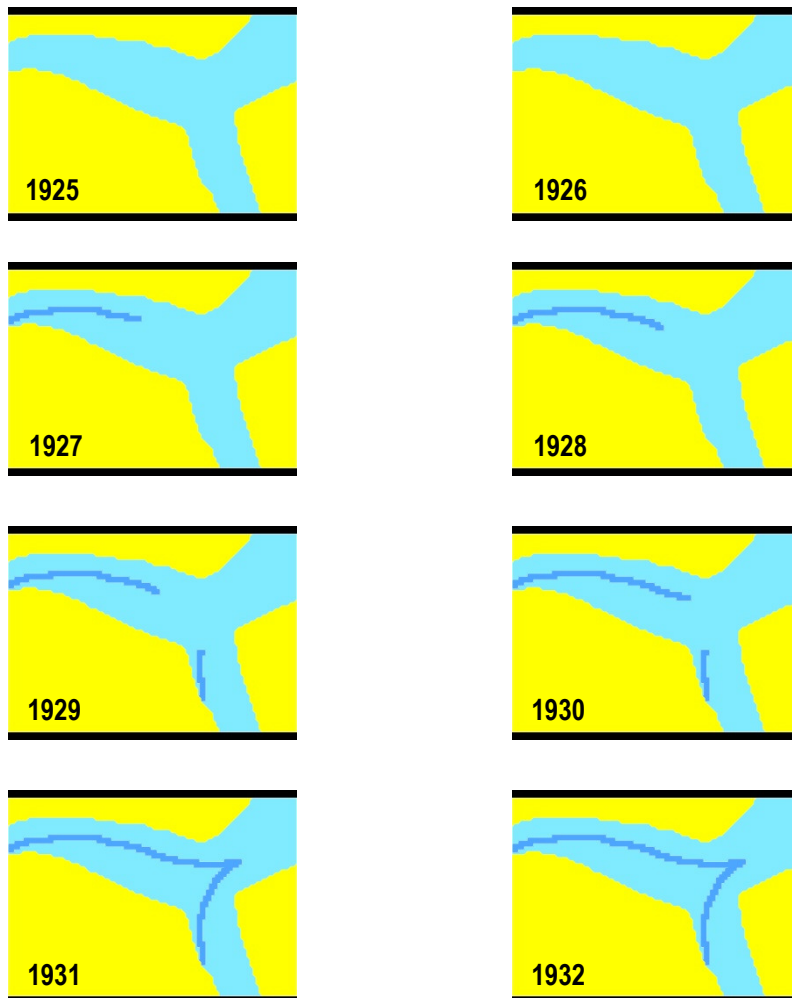
Figure 2: Stages of Trent Falls training wall construction

The records for the Training Walls at Trent Falls are very sparse, but various reports and charts indicate that they were constructed in a piecemeal process between 1926/1927 through to 1939, with most of the work being done in the early 1930s. The works were started at the upstream end of the River Ouse and continued to the Apex at Trent Falls. The work was done in stages, with no reclamation behind the walls and caused no changes in the tidal prism. There is still no reclamation to this day, but saltmarsh has built up behind due to natural reclamation.

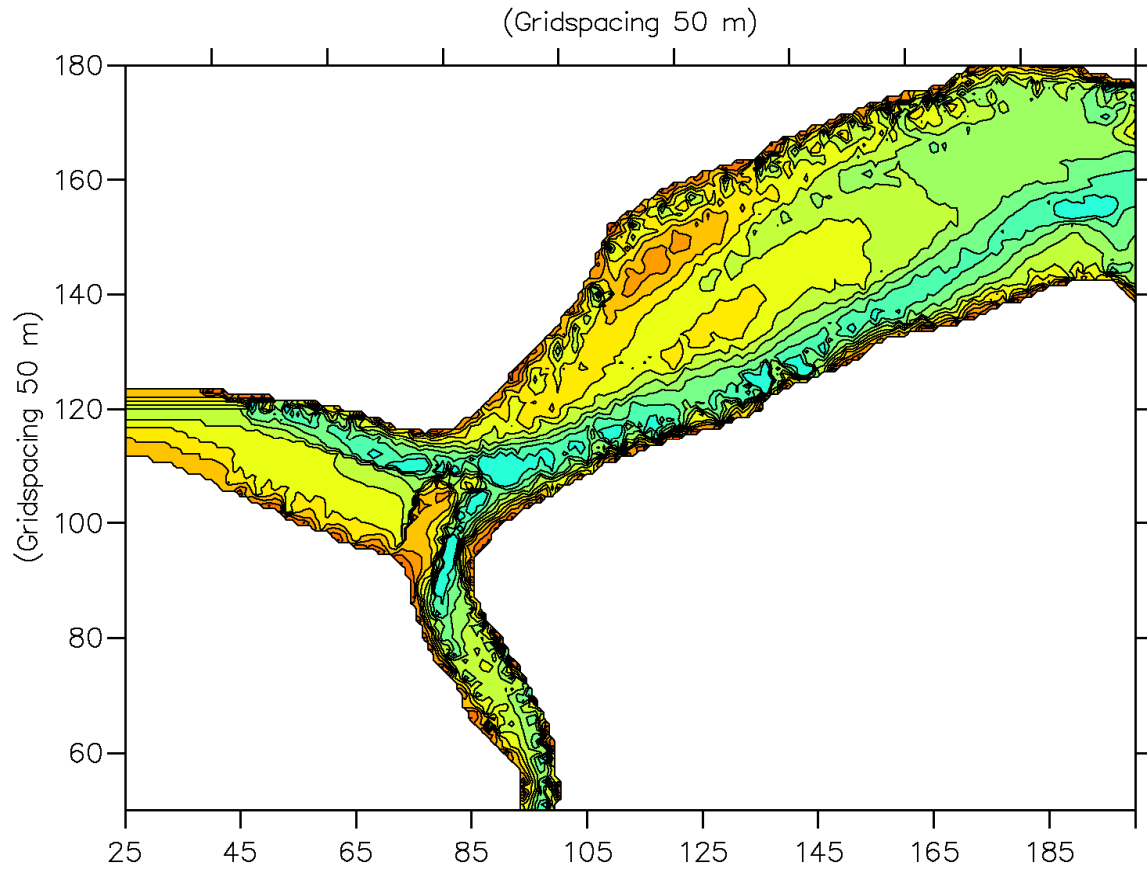
Figure 3: 1936 Bathymetry

From bathymetric evidence post works, the bathymetry has become much more stable within the Whitton Reach and Whitton Sands has been seen to naturally accrete over the years and is now saltmarsh. The Broomfleet Channel is now also filled in.
